Manhole Inspection Summary

Manhole # S51CC_007MH

Insp Date: **2/20/08 11:32 AM**

Location Address: **Curly-Linwood**

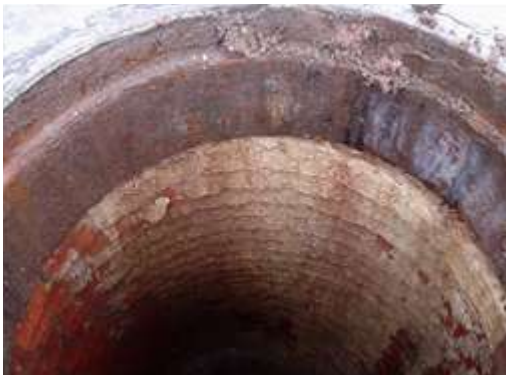
Defect 3

Chimney / Frame Adjustment ☒ Exists Material: **Brick** ☐ Parged Height: **9** (in.)

Adjustment Frame

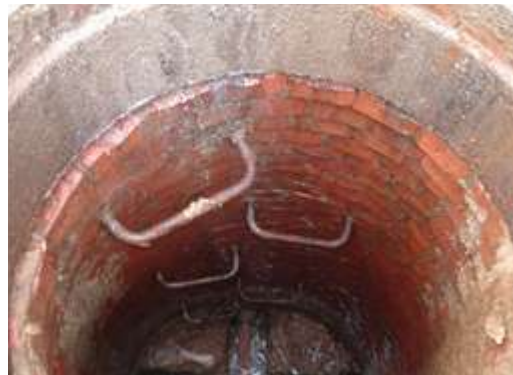
Defect 1

Frame Offset: **0.5** (in.) Condition: ☐ Sound ☐ Cracked ☒ **Leaks**

Offset

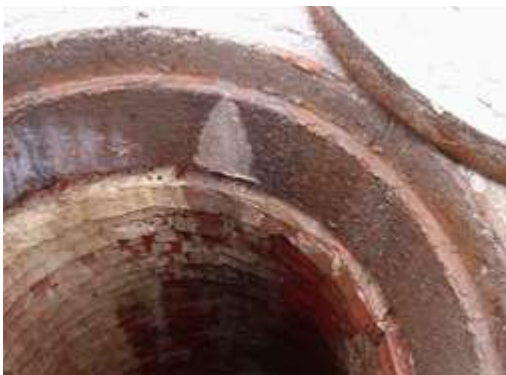
Defect 2

Frame Leaks

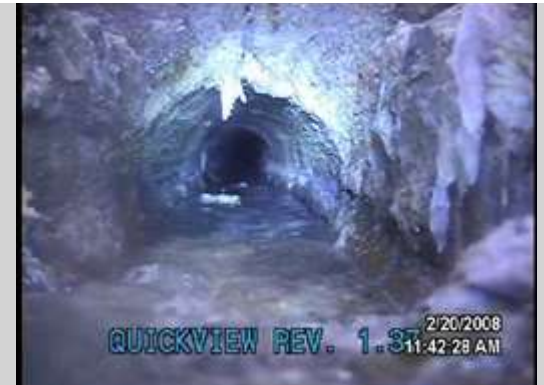
12 O'Clock Outflow

8 in. Circular Gravity Sewer
Pipe Out @ 12 O'Clock

Pipe Height: **8.4** (in.) Rod and Bar (Angled)
Pipe Material: **Clay** ☐ Pipe Lined
Invert Depth: **10.50** (ft.) Flow Characteristics: **Fast**
Deposits: ☐ None ☐ Mud ☐ Sludge ☒ **Debris** ☐ Grease
Silt Depth: **1** (in.) Deposits Extent: **Light**
Infiltration: **None** Pipe Seal Cond: **Sound**

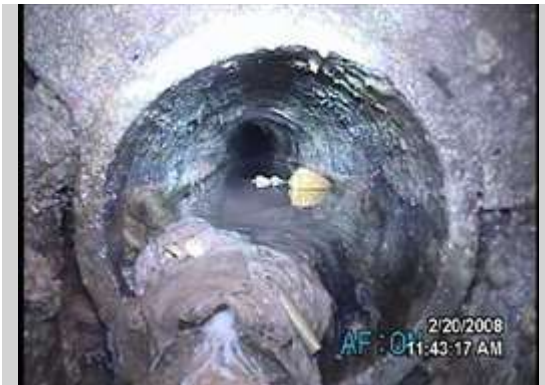
3 O'Clock Inflow

8 in. Circular Gravity Sewer
Pipe In @ 3 O'Clock

Pipe Height: **8.4** (in.) Rod and Bar (Angled)
Pipe Material: **Clay** ☐ Pipe Lined
Invert Depth: **9.90** (ft.) Flow Characteristics: **Fast**
Deposits: ☐ None ☐ Mud ☒ Sludge ☒ **Debris** ☒ Grease
Silt Depth: **5** (in.) Deposits Extent: **Heavy**
Infiltration: **None** Pipe Seal Cond: **Sound**

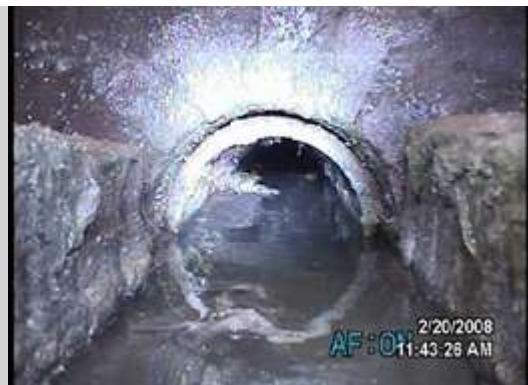
6 O'Clock Inflow

8 in. Circular Gravity Sewer
Pipe In @ 6 O'Clock

Deposits: ☐ None ☐ Mud ☒ **Sludge** ☒ **Debris** ☐ Grease

Silt Depth: **5** (in.) Deposits Extent: **Heavy**
